HERITAGE RETROFIT

OLDER BUILDINGS AND SUSTAINABILITY

**THE BUILDING CONSERVATION
DIRECTORY**
SPECIAL REPORT ON HERITAGE RETROFIT
First Annual Edition
ISBN 978 1 900915 87 8

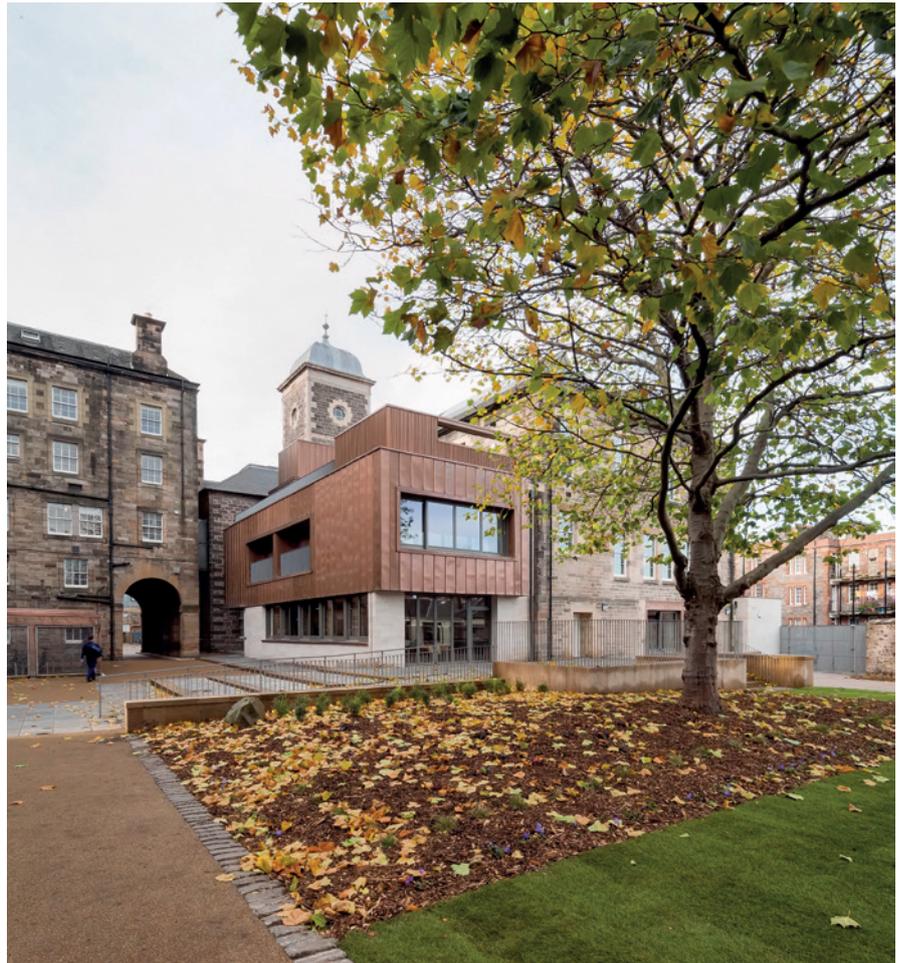
The Edinburgh Centre for Carbon Innovation, which opened in 2013, is a category A listed former school. Its refurbishment used low carbon materials including highly engineered timber and reclaimed steelwork. It is the first refurbished historic building in the UK to achieve a BREEAM 'Outstanding' rating. (Photo: Dave Morris)

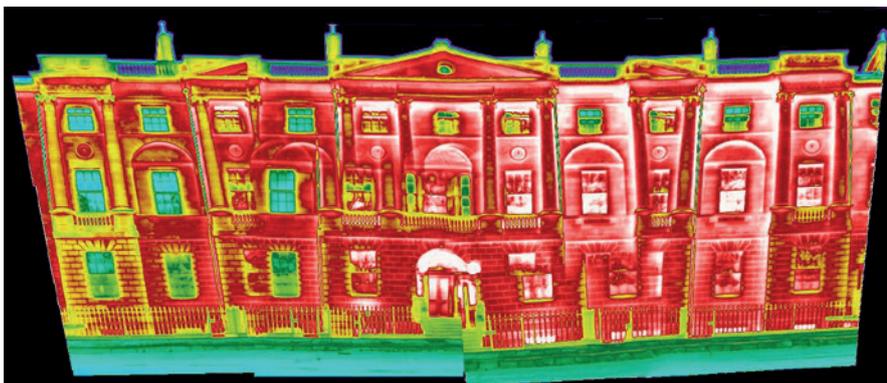
Thermal image composition showing heat loss from Bute House, Edinburgh (Image: Kal Murray, Eco Surveys)

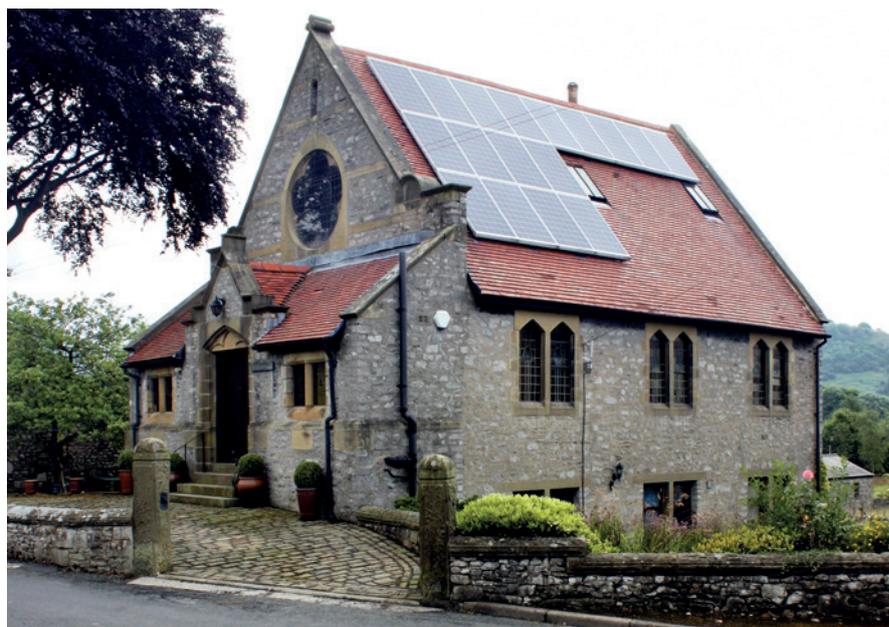
Austwick, Lancashire: house conversion. Heritage significance subsumes appearance and material fabric. In this case, whereas the material fabric has been retained by overlaying solar panels, the building's appearance has been seriously compromised. Advances are being made in the production of solar roof tiles, also shingles and slates, which protect the overall as well as detailed appearance of historic buildings but require substitution of the fabric. The heritage impact methodology outlined in this article facilitates informed and transparent decision-making in situations where choices have to be made. (All photos: Dennis Rodwell)

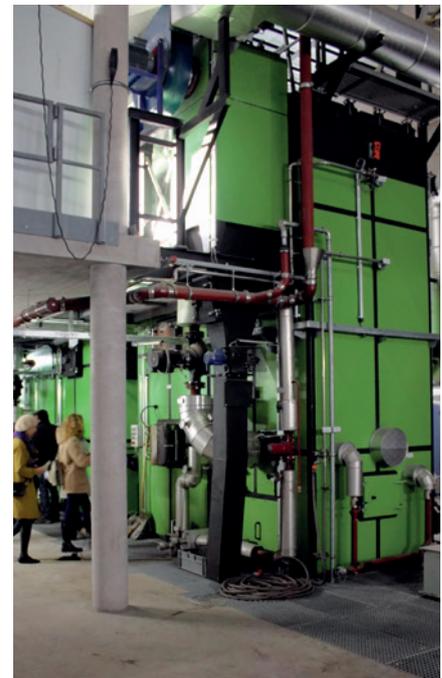
Lörrach, Baden-Württemberg, south-west Germany: biomass-fuelled urban-district heating plant. District energy systems, whether for heating/cooling or electricity, are more cost-effective and sustainable and avoid impacting on the heritage significance of individual buildings.

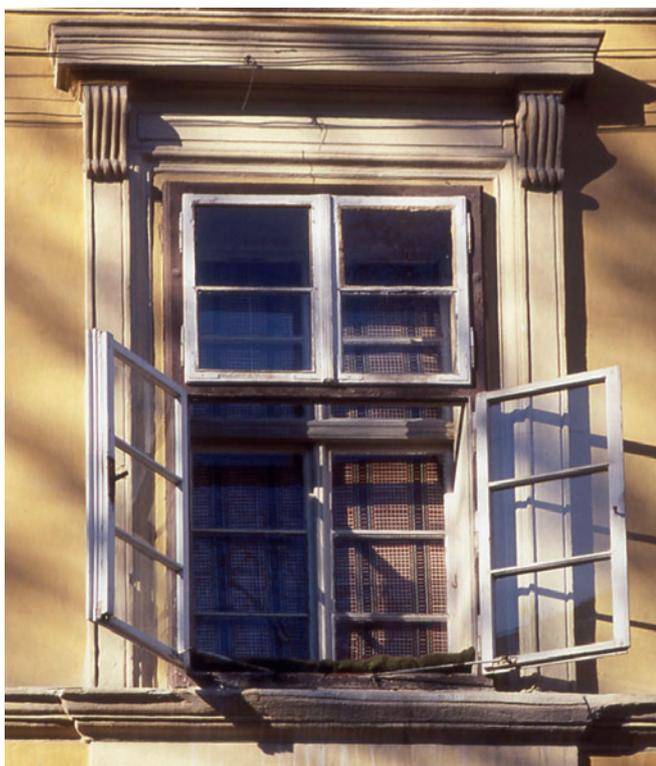
Sibiu, Romania: historic double windows, typical of those found throughout Central and Eastern Europe

Double windows and secondary glazing, which tests have demonstrated to have thermal characteristics at least as good as if not better than sealed glazing units, have been the norm across much of continental Europe for centuries. They often offer a viable alternative that accords with the heritage principle of minimum intervention, is not subject to failure of the glazing technology, and is highly durable.

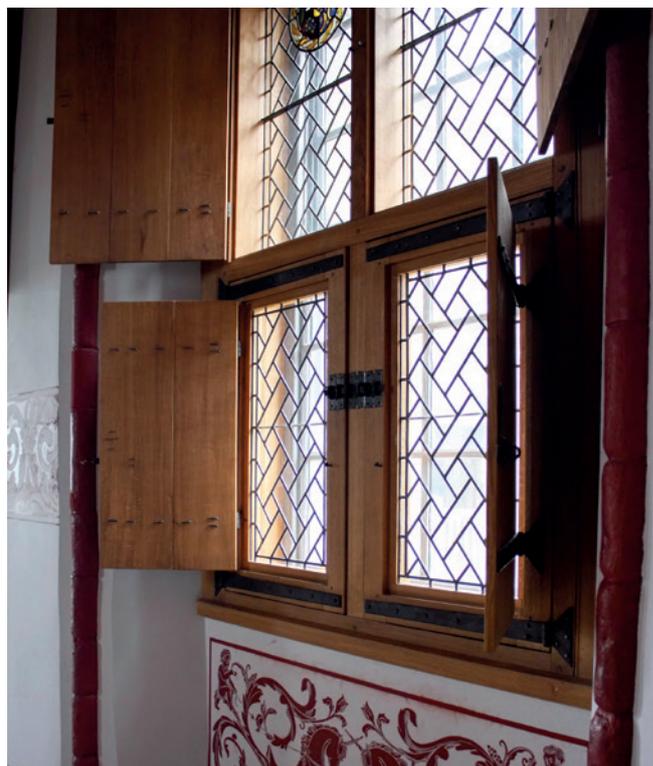
Stirling Castle, Scotland: crafted secondary glazing and shutters have been installed as part of the restoration works in the royal apartments.

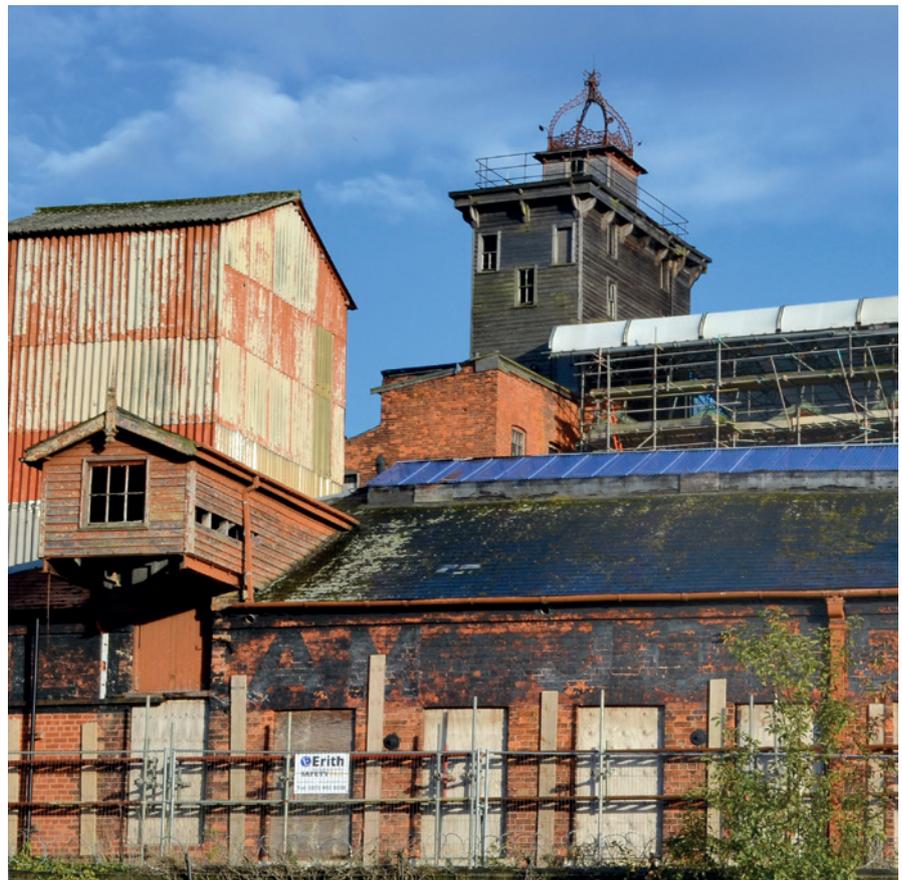
Shrewsbury Flaxmill Maltings (Grade I, 1797), where Historic England is assessing the effects of internal wall insulation on the hygrothermal behaviour of brickwork (Photo: Jonathan Taylor, all other images: Iain McCaig/Historic England)

Two systems of internal wall insulation, similar to those used at New Bolsover, have been installed in trial areas on three exterior walls in a room in the engine house adjoining the main mill. The 1½-brick thick walls face south, east and west respectively. The monitoring set-up is similar to that at New Bolsover, except that wooden dowel moisture sensors have been installed in holes drilled in the walls to within 50mm of the external faces. This allows moisture profiles through the thickness of the wall to be obtained, in addition to heat and moisture transfer

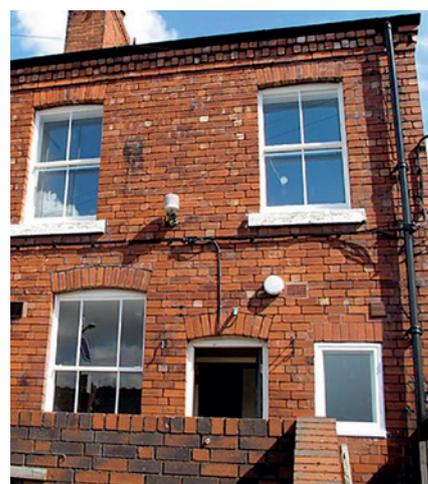
Victorian end-of-terrace in New Bolsover, Derbyshire before (above) and after (below) installation of loft insulation, secondary glazing, internal wall insulation and insulation of the suspended timber ground floor. These thermal improvement measures increased the building's SAP rating from E (46) to C (73).

New Bolsover is a model village built by the Bolsover Collier Company in 1891 on the outskirts of Bolsover, Derbyshire. It comprises 206 two- and three-storey brick houses (Grade II listed) arranged in double terraces on three sides of a square village green. In 2011 Historic England (then English Heritage) leased an end-of-terrace two-storey brick house and carried out a package of measures to improve the energy performance of the building envelope. This included loft insulation, secondary glazing, internal wall insulation and insulation of the suspended timber ground floor. Two types of wall insulation were used for comparison: a non-hygroscopic, vapour-closed system (polyisocyanurate or 'PIR'), and a hygroscopic, vapour-open system (wood fibre).

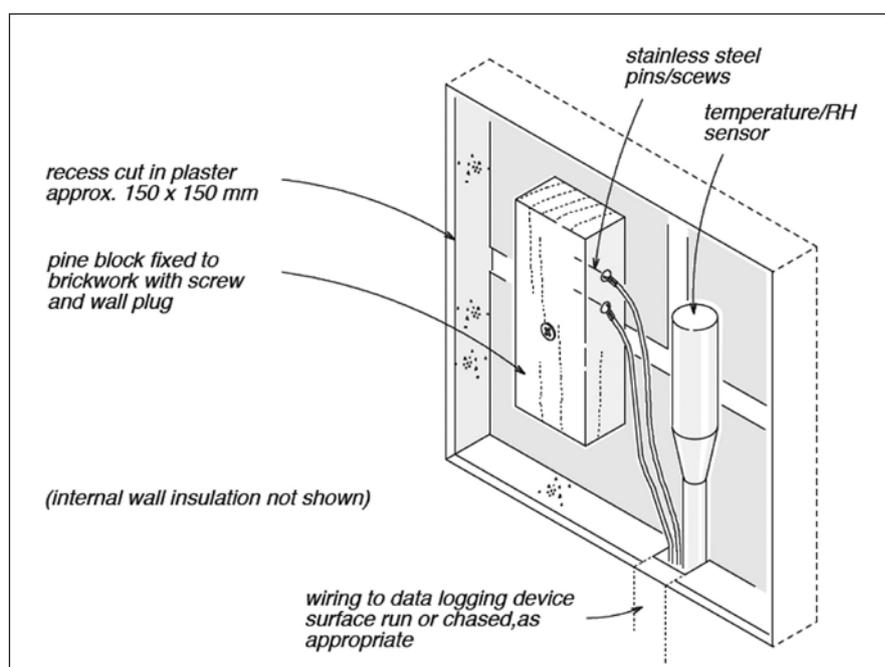
Hygrothermal monitoring set-up at New Bolsover. Wooden blocks (or dowels) are a convenient method for assessing moisture content in historic building materials. The moisture content of the timber equilibrates to the relative humidity of its surroundings and can be determined (within limits) from measurements of electrical resistance. The humidity of the surroundings can then be deduced.

becomes colder, its humidity increases. This prompts two questions: does the wall remain sufficiently wet for long enough to harm building fabric? And does moisture tend to accumulate over time? The sensors installed measure temperature, relative humidity and the moisture content of a small block of wood (page 7).

Moisture monitoring at New Bolsover has been carried out continuously since 2011. During this period seasonal fluctuations have been observed, with walls becoming wetter in winter and drying out during the summer months. So far, no conclusive evidence of moisture accumulation behind either insulation system has been observed, but monitoring is continuing. (The results of the work to date will be published in an interim research report which will be available for download from Historic England's website).

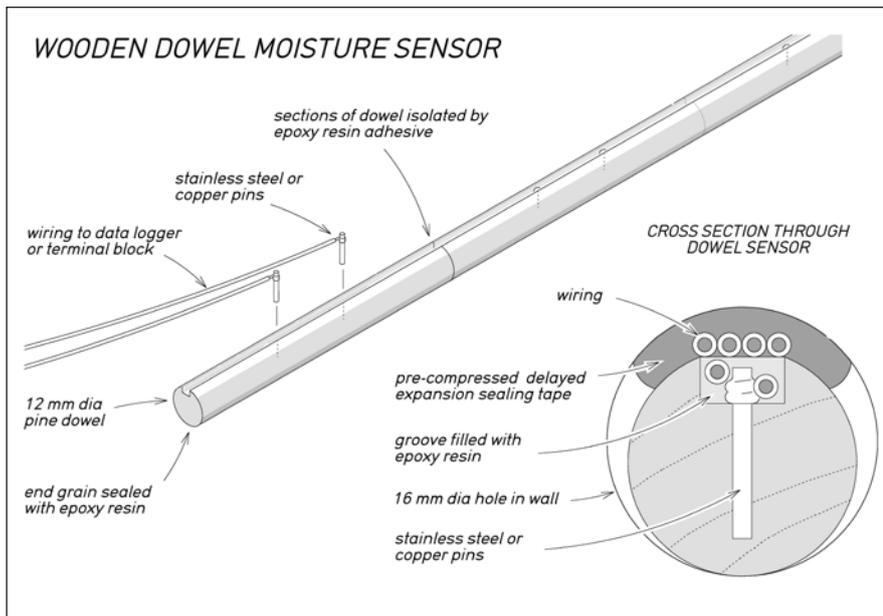
Hygrothermal monitoring set-up at Shrewsbury Flaxmill Maltings: the dowels are cut into three sections isolated by epoxy resin. The ends of the dowels are also sealed with epoxy resin. In each section there is a pair of embedded electrodes which enable the electrical resistance to be measured remotely to provide a moisture profile through the thickness of the wall.

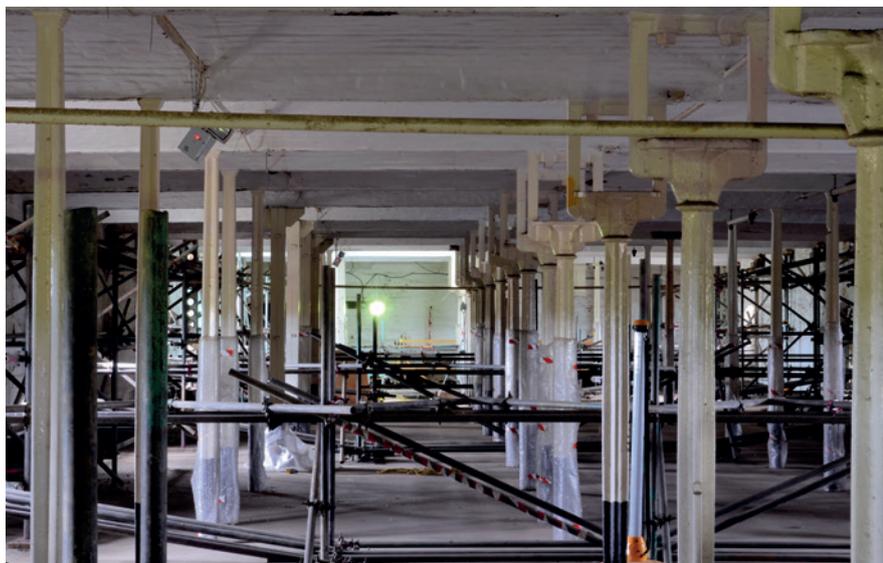
The interior of the flax mill: the line of short cast iron columns once held the drive shaft to power the looms.

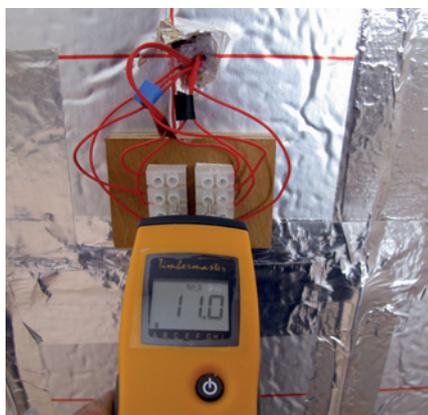
Measuring the moisture content of the dowels manually, using a resistance moisture meter. The dowels are connected to terminal blocks located to suit the spacing of the pins on the moisture meter. This enables repeated measurements to be made quickly and easily.

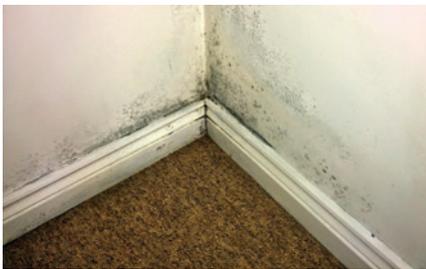
Damp and mould caused by poor external wall insulation (Photo: Centre for Sustainable Energy)

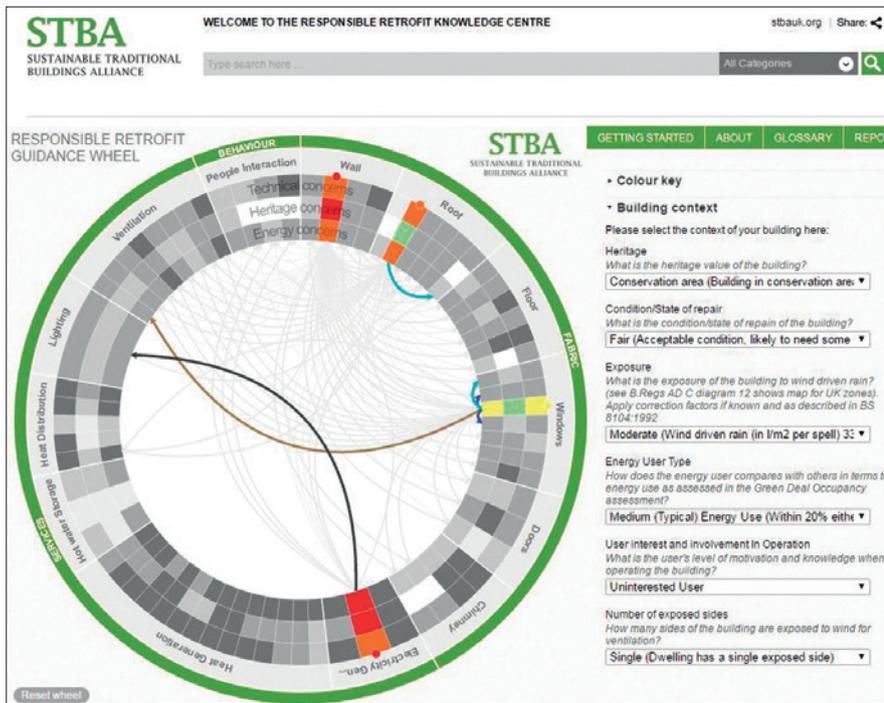
Produced by the Sustainable Traditional Buildings Alliance, the Responsible Retrofit Guidance Wheel helps users to evaluate how a range of measures might interact with each other and what risks they could pose to a given building's physical fabric and historic significance. (Image: STBA)

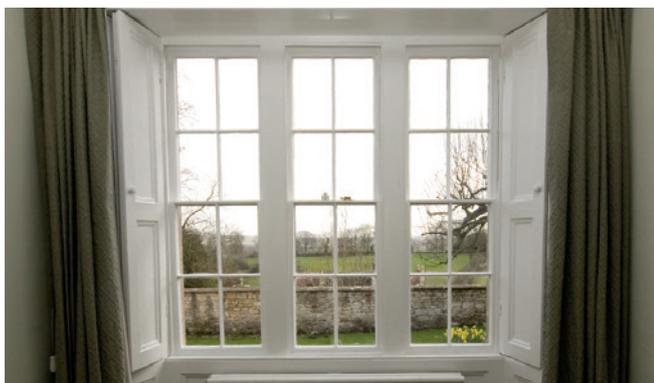
Most of the heat loss through this Georgian sash window was eliminated simply by draught-stripping. The restored shutters and heavy curtains also enabled the window to be insulated after dark.

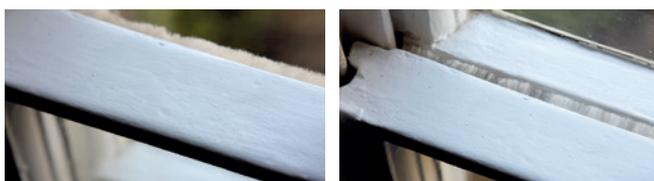
Draught-stripping on the meeting rail of the lower sash (shown open on the left and closed on the right), neatly eliminating a significant source of draughts (Photos: Centre for Sustainable Energy)

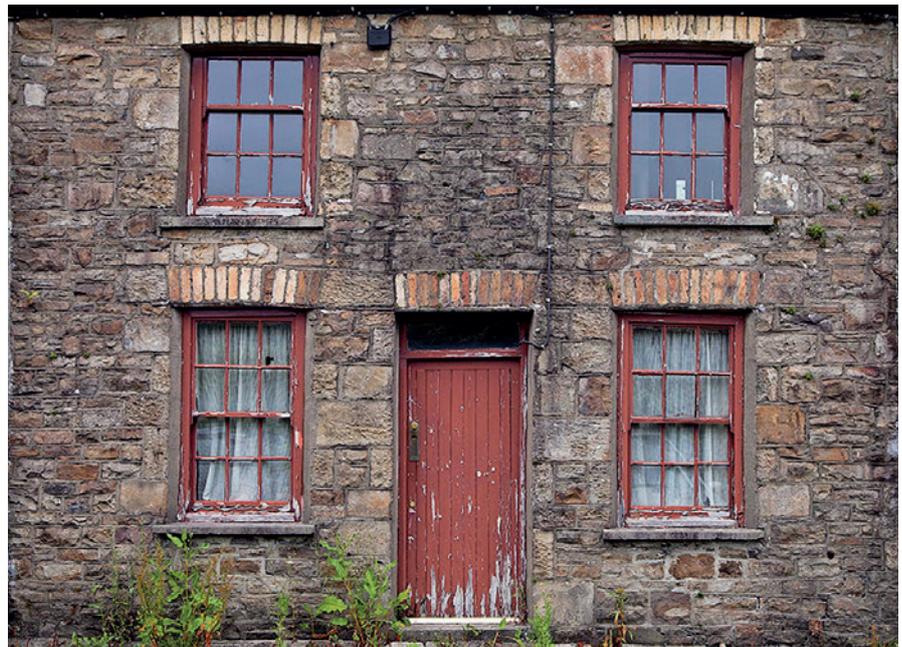
A miner's cottage in David Street, Cwmdare: analysis of the building's pathology as required under BS 7913: 2013 provided information on the effects of damp on the in situ U-value, and demonstrated that the walls were more thermally efficient than predicted. (Photos: John Edwards)

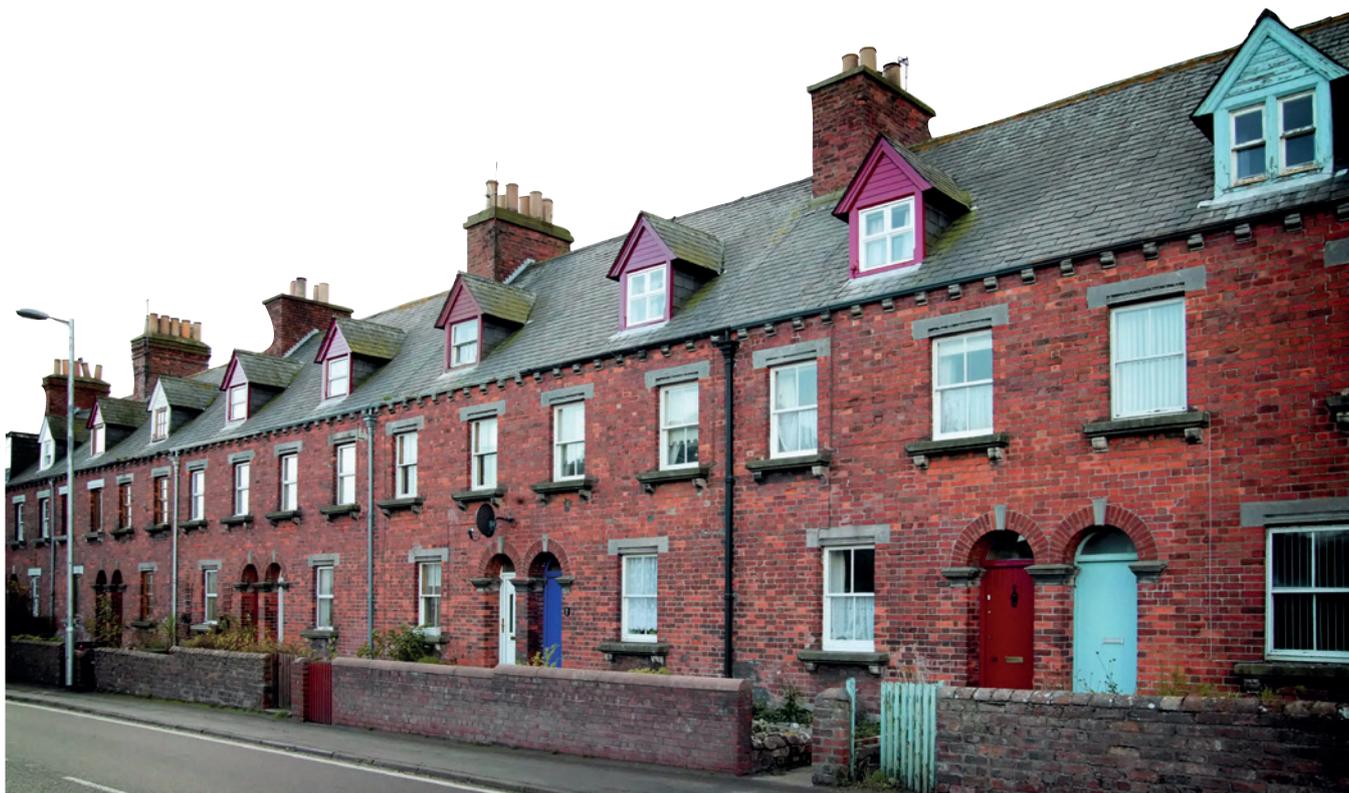
Proposals are sometimes put forward for external wall insulation to be applied intermittently to the front elevation of individual houses in a terrace, despite there being features of architectural interest. A heritage impact assessment may prevent alterations like this from happening. Aesthetics are not the only consideration under the significance umbrella, but assessing significance will inevitably mean a greater likelihood of external wall insulation being applied to plain rendered elevations than to very ornate elevations with bay windows. This terrace is somewhere between the two, which is where the more difficult decisions lie. (Photo: Historic Environment Scotland)

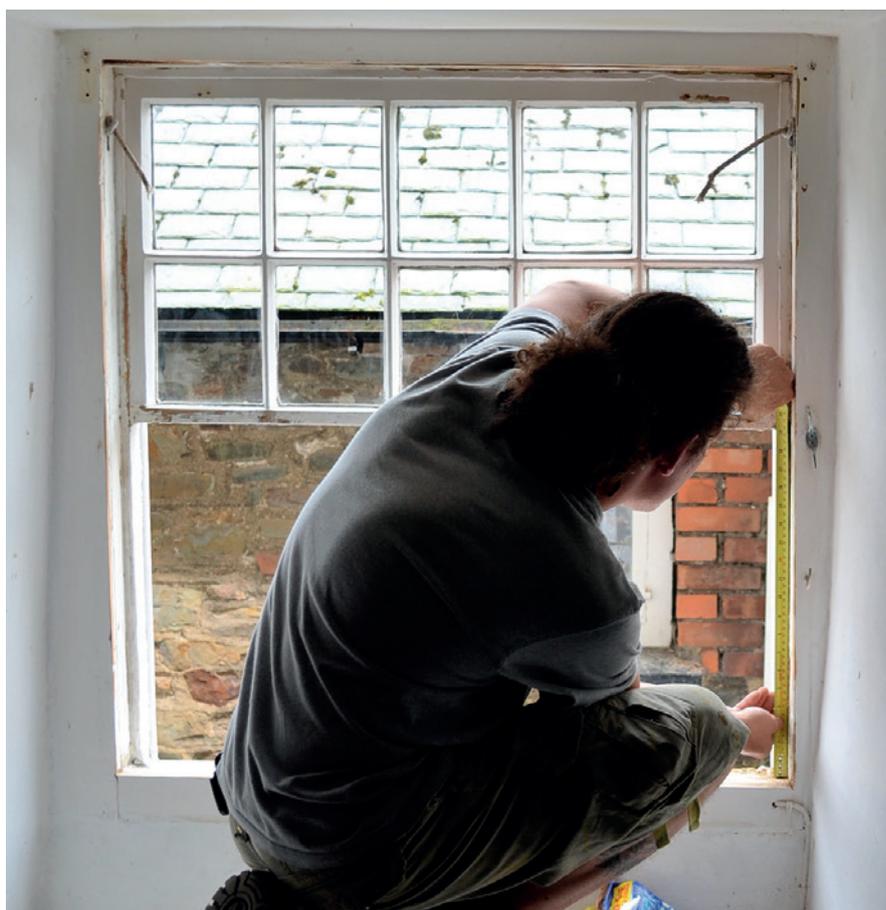
Above, draught-stripping sash windows at Clovelly, Devon as part of the programme of EPC improvement measures and, top left, simple secondary glazing fitted to a casement window. (Photos: Jonathan Taylor)

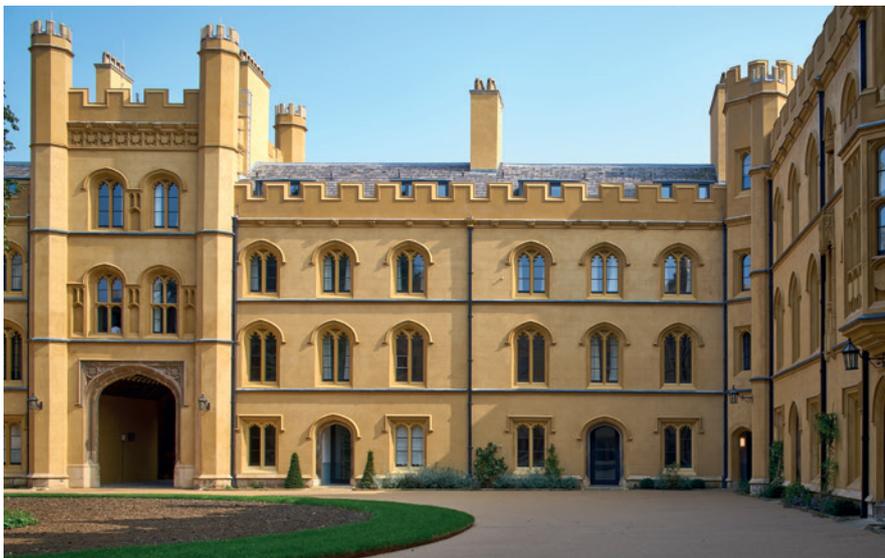
Originally the façades facing the courtyard were all rendered with Roman cement, later repairs were executed in cement, and they have now been re-rendered using a more permeable hydraulic lime painted with limewash (above).

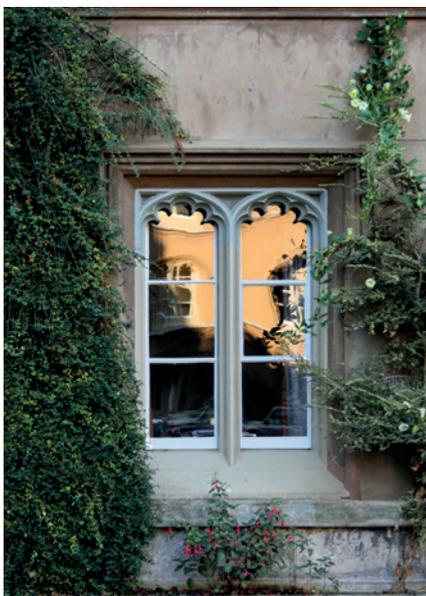
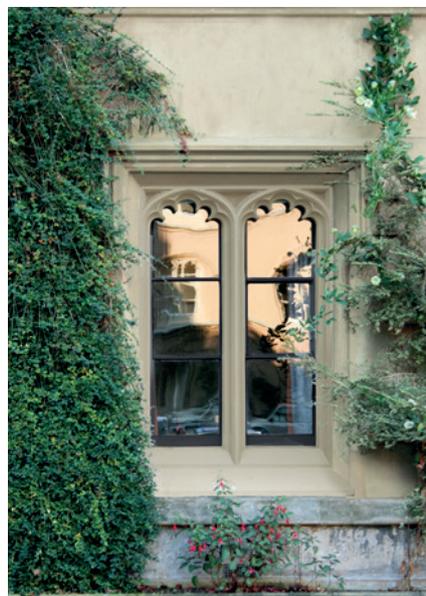
One of the windows facing the courtyard (left) at the start of the project, and (right), the same image modified to show the architect's proposals for re-colouring the walls and window frames, following surviving evidence of the original colour scheme (All photos: Tim Soar)

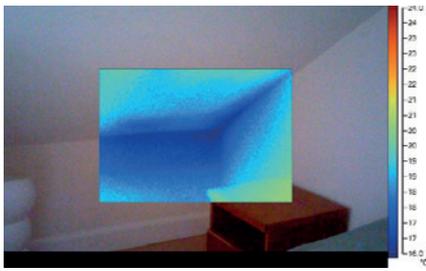
Thermal image showing the cooling effect of condensation and poor insulation in one of the attic bedrooms: the ceilings (modern gypsum plaster on metal lath) were stripped out and replaced with insulation below and between the rafters to achieve a U-value of $0.15\text{W}/\text{m}^2/\text{°C}$ and air-tightness of $3.0\text{m}^3/\text{h}/\text{m}^2@50\text{Pa}$. (Image: ArchiMetrics)

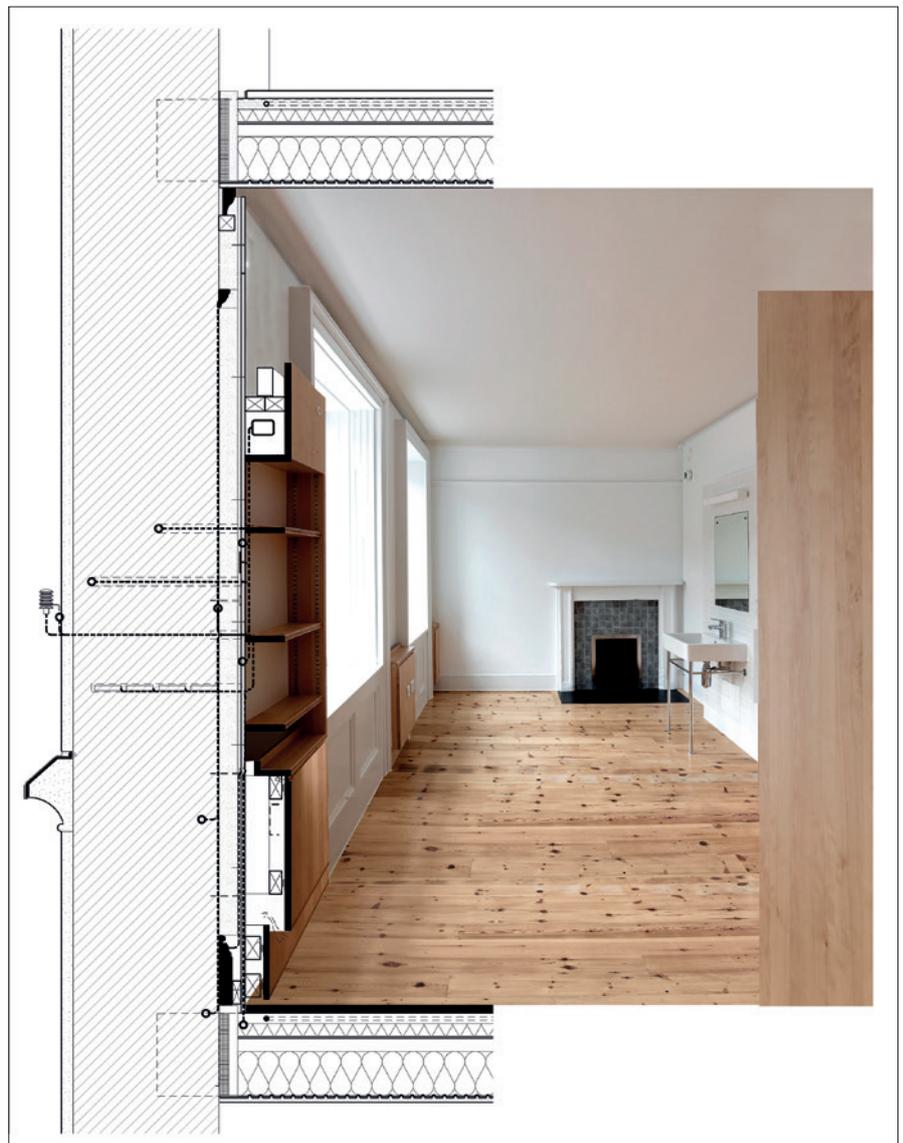
Computer modelling indicated that the cooling effect of a 60mm-lining of vapour permeable insulation would not cause an unacceptable increase in moisture in the masonry, but long-term monitoring was essential. The diagram shows an external weather station and probes installed at different depths in the masonry to monitor changes in temperature and relative humidity. (Image: 5th Studio)

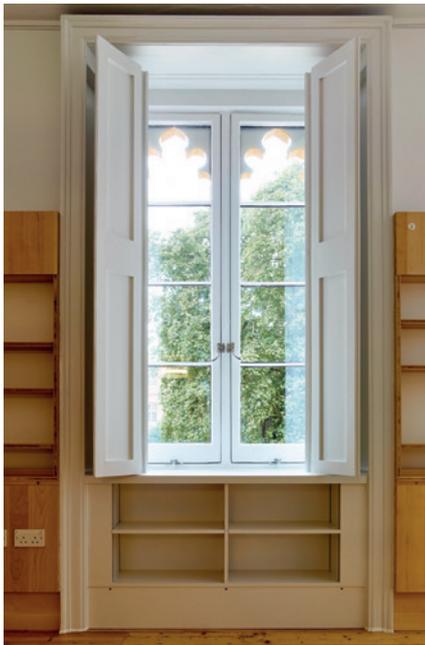
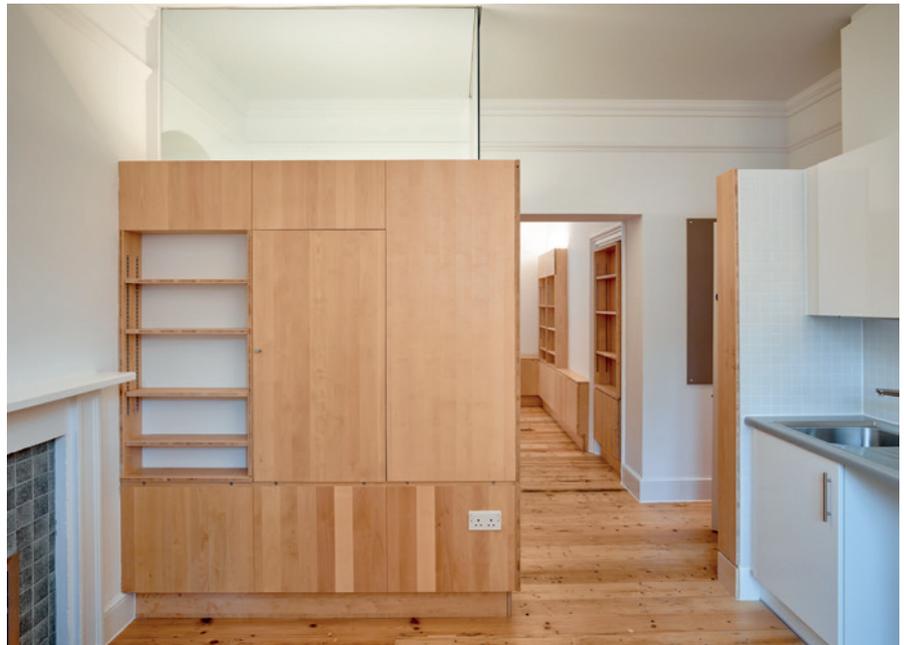
Window shutters and architraves (left) were brought forward slightly to accommodate secondary glazing, security fixings and wall insulation. Bookcases and other fittings on either side were designed to accommodate services and (right) to hide an en suite shower. All showers were located away from exterior walls to avoid contributing to the moisture load. (All photos: Tim Soar)

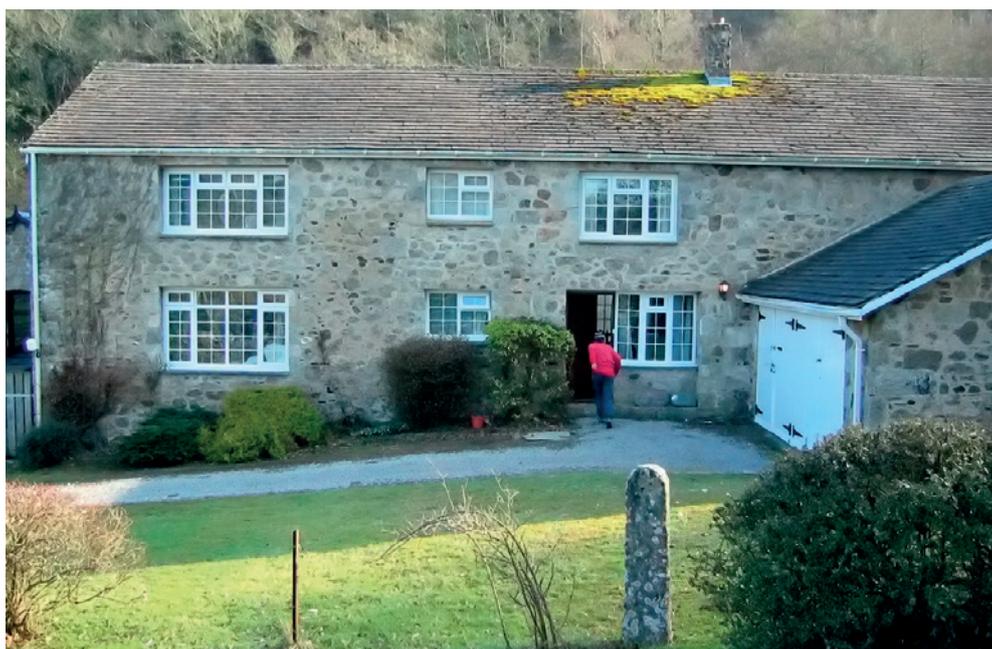
North-west facing granite wall in Drewsteignton, Devon: one of two internally insulated solid walls featured in the Building Performance Survey, this 600mm granite wall had been internally insulated with 100mm of polyisocyanurate board with an air gap and a plasterboard and gypsum skim finish.

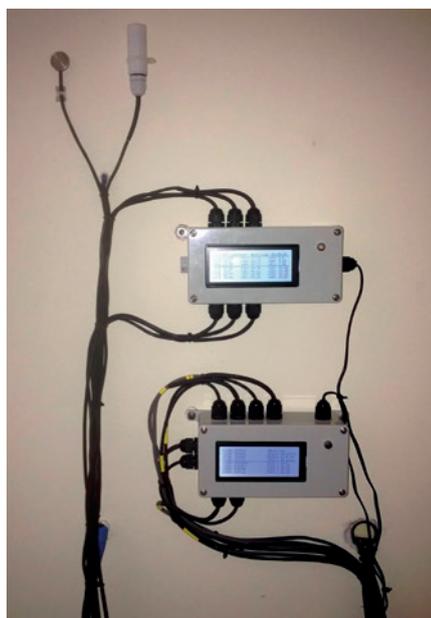
Monitoring equipment installed on the internally insulated granite wall at Drewsteigton

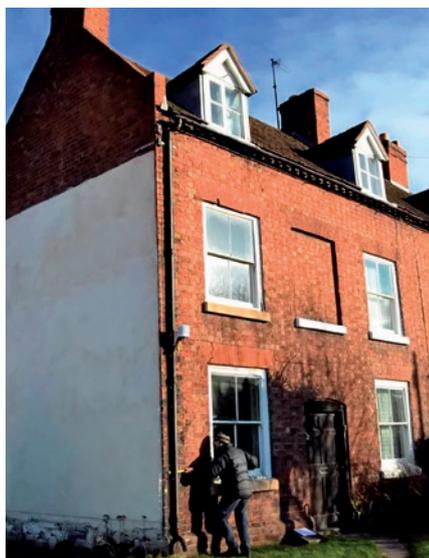
Monitoring a south-facing brick wall at Shrewsbury

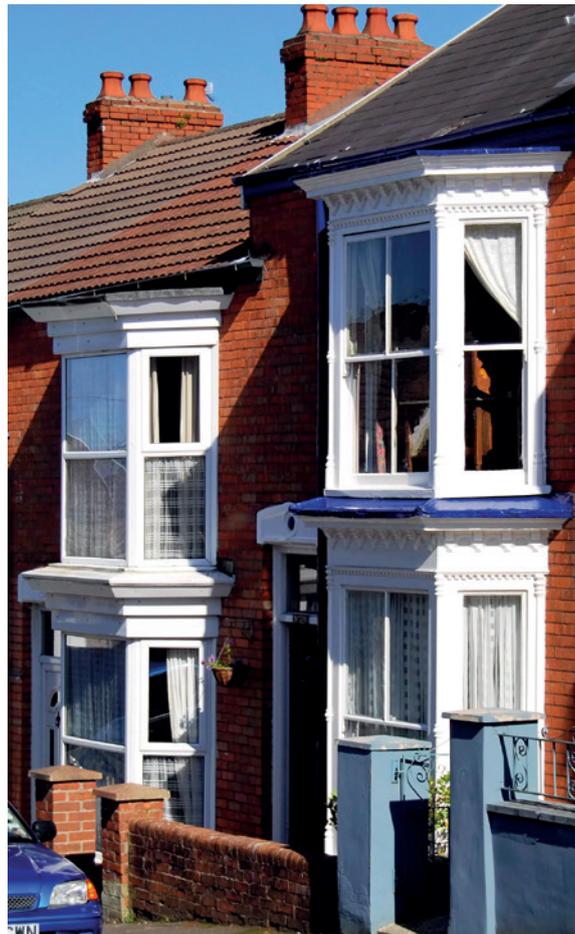
Solid brick walls, bay windows and tiled roofs in a typical Edwardian terrace. Venting top and bottom, the original vertical sliding sashes (right) offer controlled and highly efficient air circulation when retrofitted with draught seals.

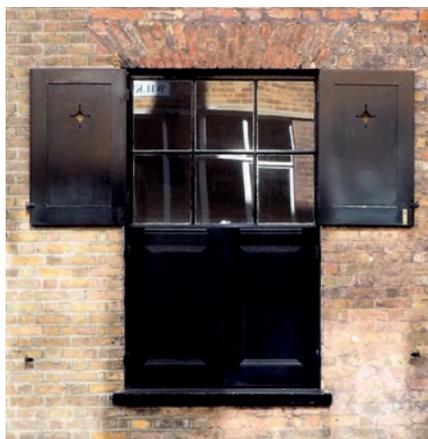
Shutters on the ground floor of a Georgian terrace in Spitalfields, London: commonly used on the continent to keep interiors shaded and ventilated during the day, here the focus was on privacy and security.

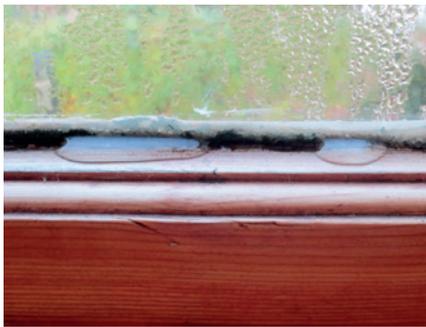
Condensation on a window pane is often a good indicator of inadequate ventilation.

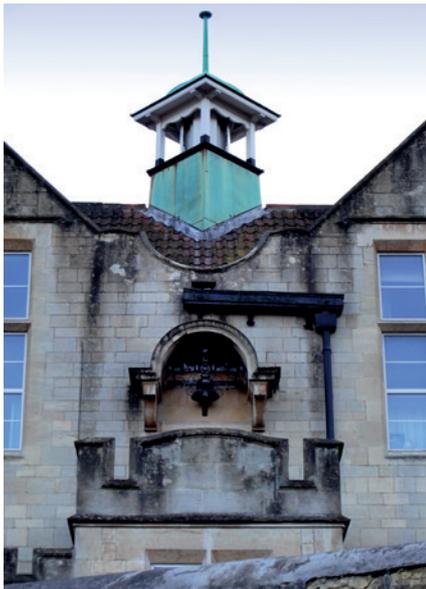
A 1930s copper cupola providing passive stack ventilation on a former school building in Bath

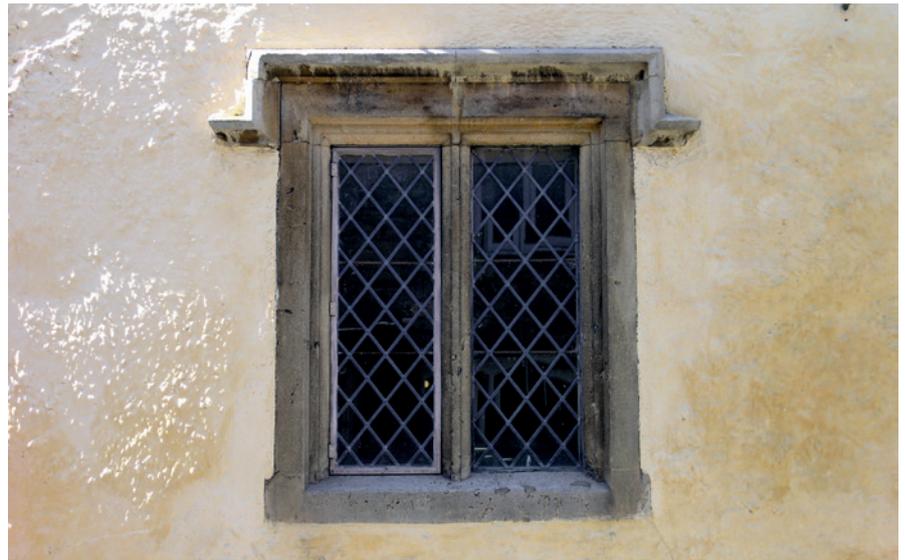
A traditional roughcast lime render on a solid masonry wall

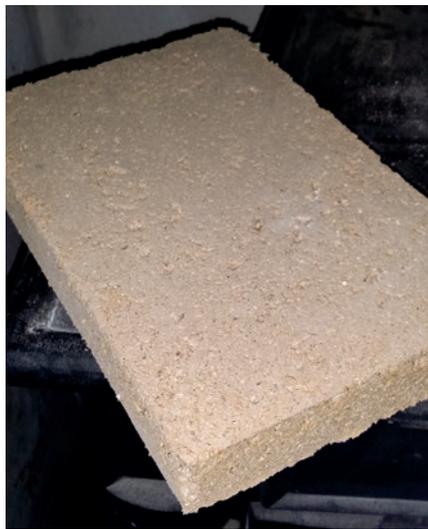
One of the pre-production insulation panels tested, 62mm (2½") thick

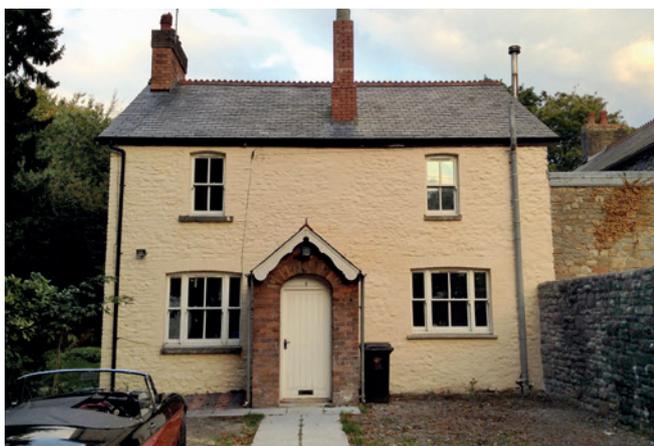
Mill Cottage on completion of repointing and lime-washing using Vivus materials

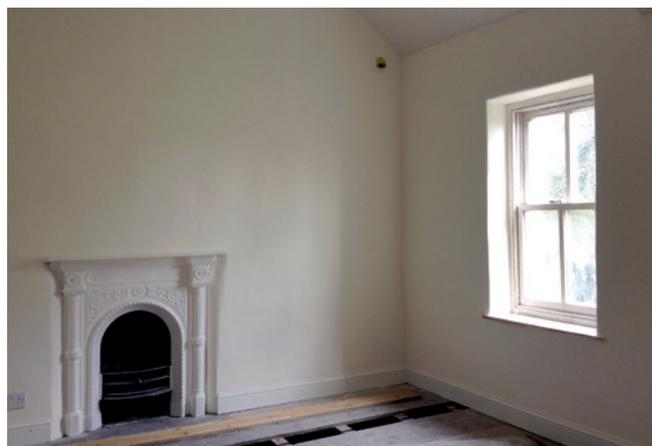
Fireplace and window details, with insulated walls, plastered and finished

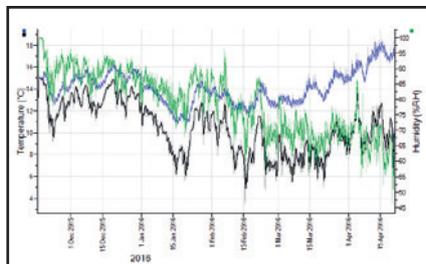
Sample data recorded following the work at Mill Cottage showing a marked fall in dewpoint (black) and relative humidity (green) from December 2015 to April 2016, while temperatures (blue) rose. During this period the house was uninhabited and the weather in this exposed location was particularly cold and wet.

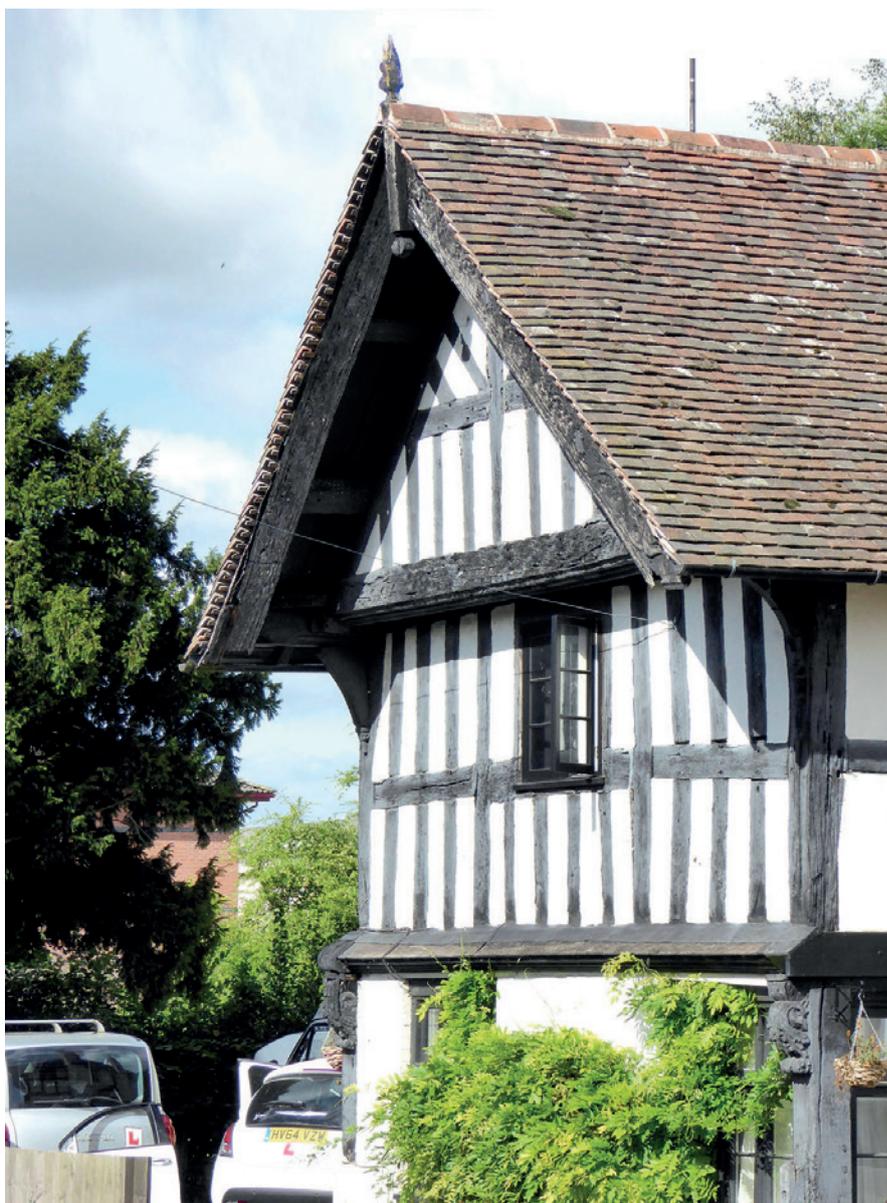
The large original verge overhangs of this historic timber-framed house protect the wall below, while an angled 'pentice' board above the ground floor window sheds water away from the wall below. (All photos: Robert Demaus)

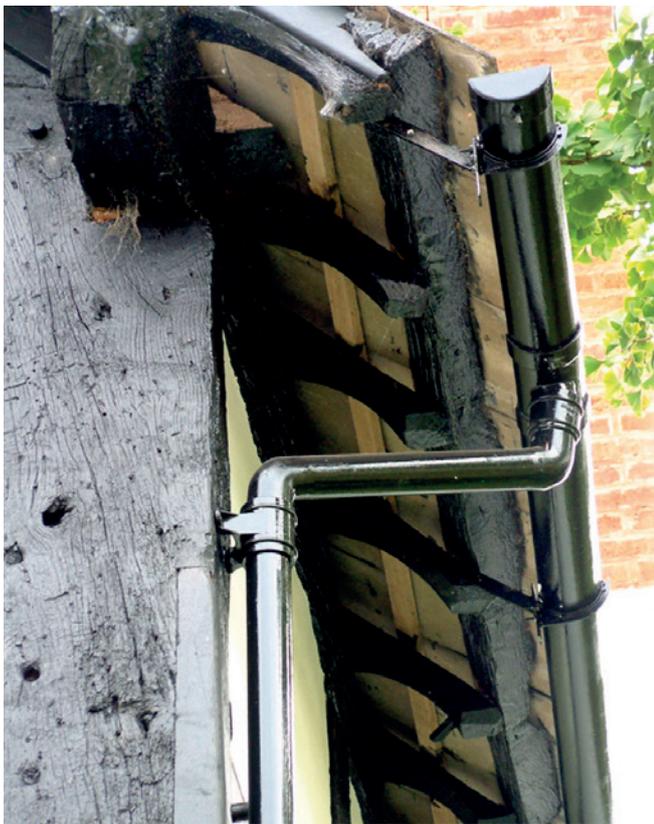
This timber-framed house has retained its original eaves and verges, both beautiful and practical. The house must always have been tiled.

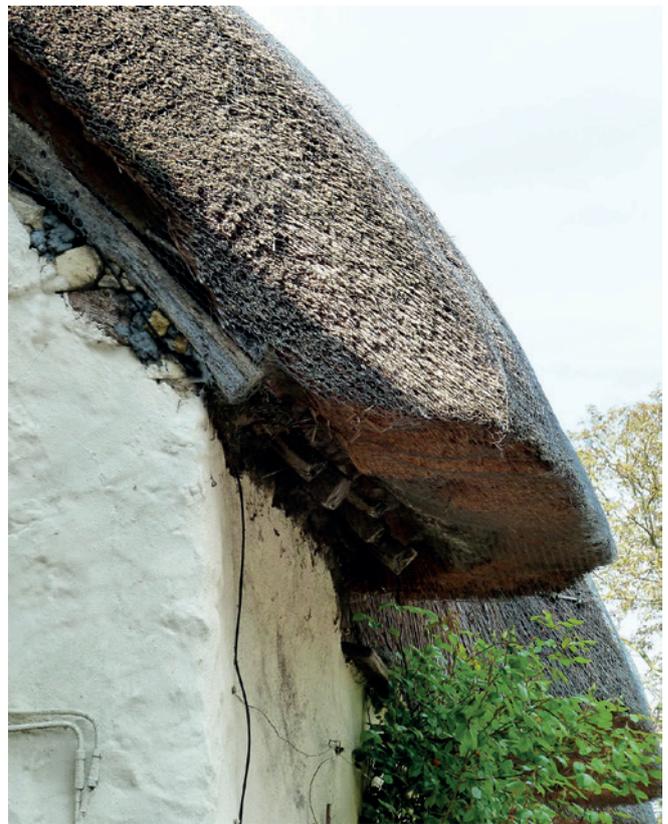
The depth of thatch shelters the wall below. If the thatch were replaced with tile or slate (as so much was) the wall becomes very vulnerable.

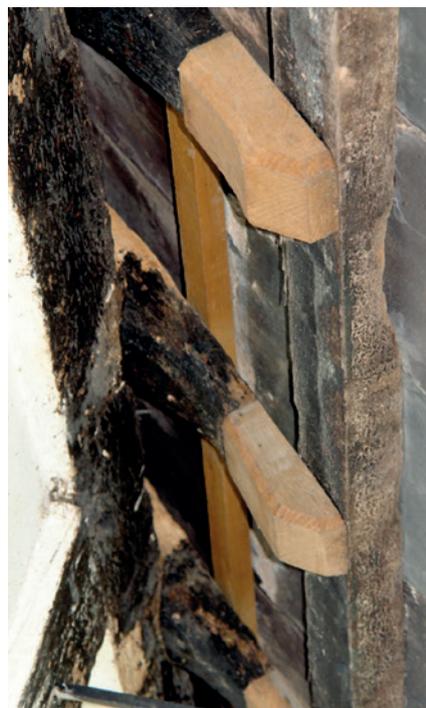
These rafters have been restored to their original overhang, greatly improving protection of the wall below.
