HERITAGE RETROFIT

OLDER BUILDINGS AND SUSTAINABILITY

**THE BUILDING CONSERVATION
DIRECTORY**
SPECIAL REPORT ON HERITAGE RETROFIT
First Annual Edition
ISBN 978 1 900915 87 8

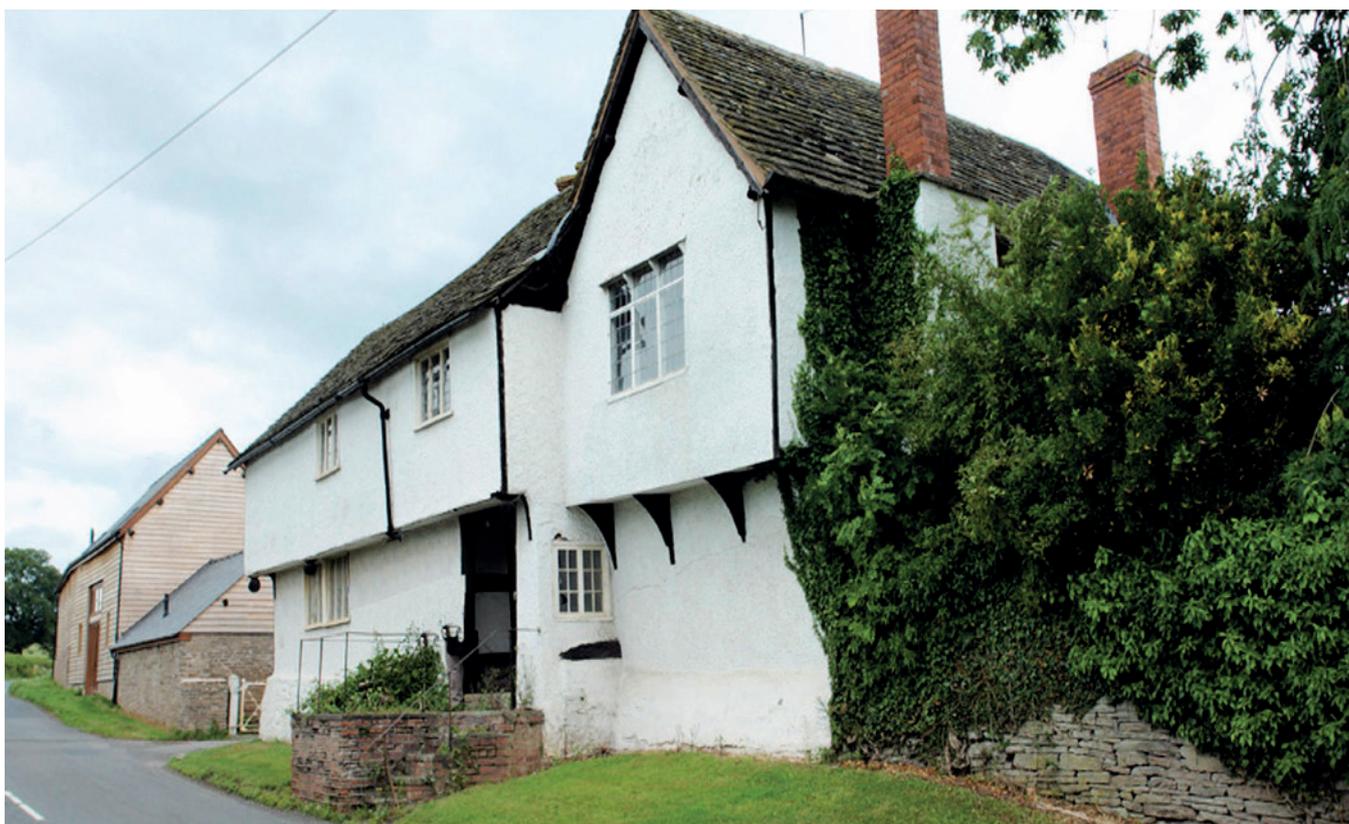
Historically, many timber-framed buildings were rendered to improve their weather-tightness. Some of the visible render is lime-based and probably early 19th century, other sections have been replaced with a cementitious render in the 20th century.

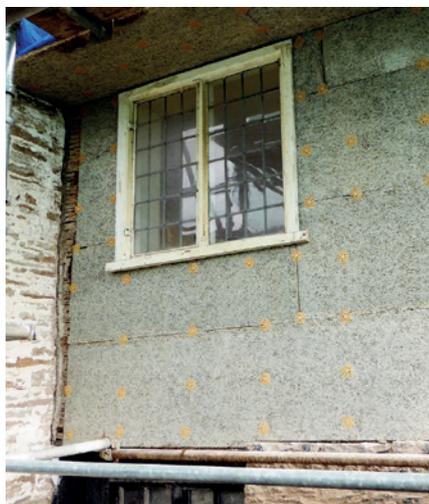
Wood-wool insulation boards ready for lime rendering

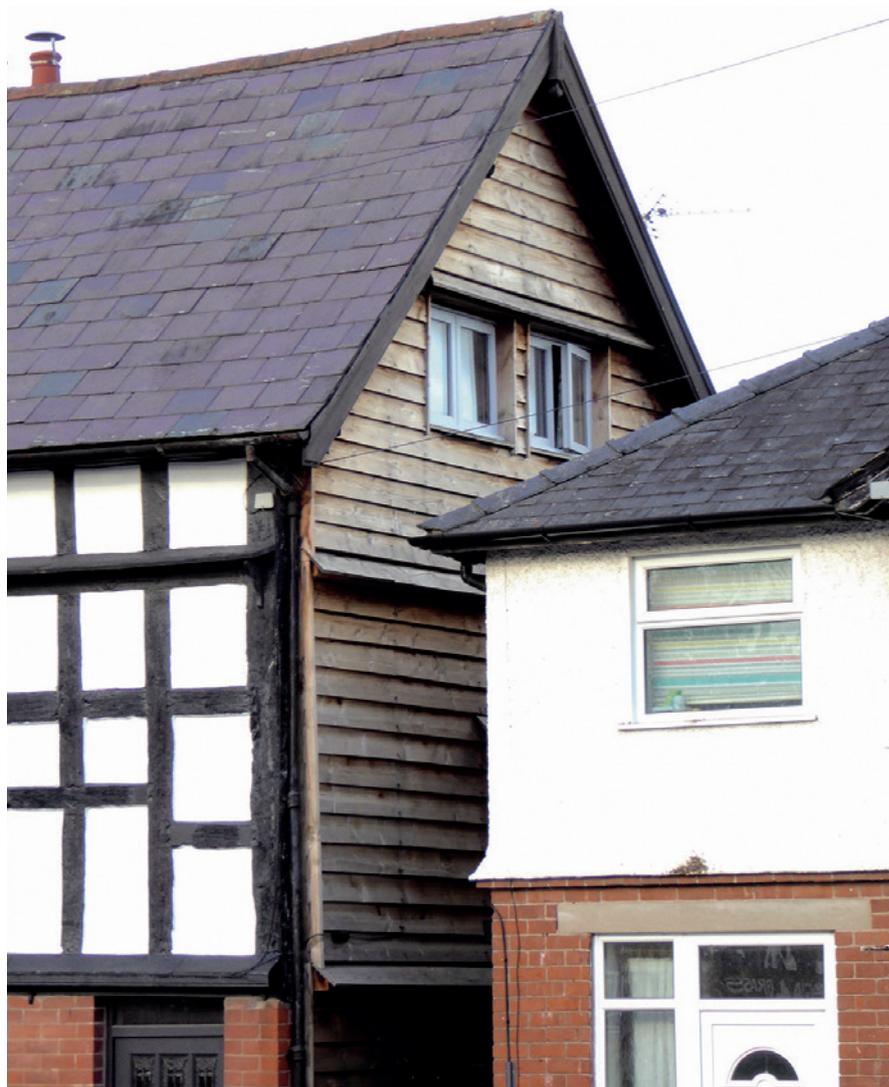
The severely degraded timber framed end wall has been strengthened and protected behind weatherboarding, with a layer of breathable multi-layer insulation included.

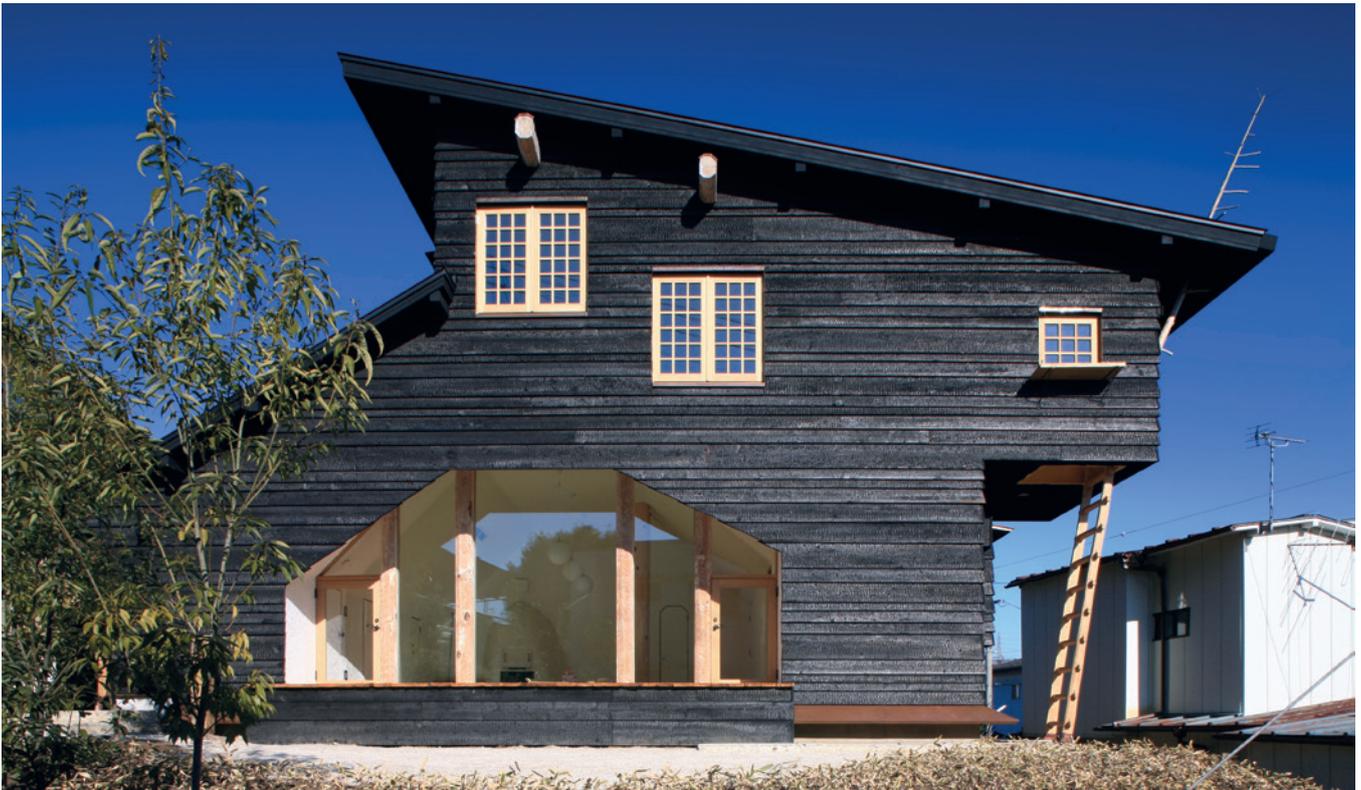
Yakisugi cladding on a house designed by Terunobu Fujimori in Utsunomiya, Tochigi Prefecture, Japan (Photo: Dana Buntrock, Flickr)

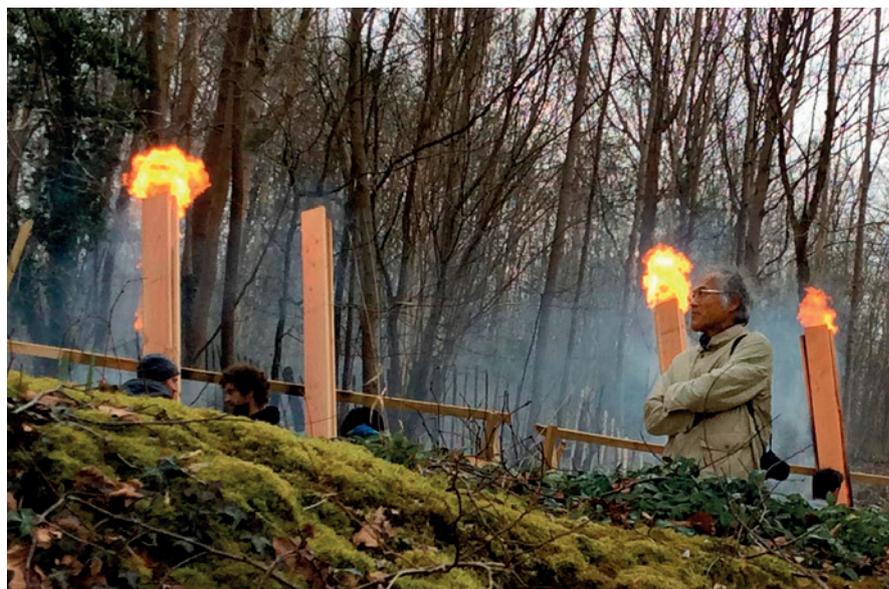
Professor Fujimori oversees the charring process

Yakisugi making was demonstrated by 71-year-old Professor Fujimori. Three-metre long Douglas fir planks were bound together with wire to create triangular chimneys and a ball of newspaper was lit at the base and pushed up inside. As the fire caught the inside faces of the triangulated planks, the intense flames produced a thick layer of charcoal. Fujimori opened up the corners of the bundles, carefully controlling the flames and ensuring even charring of the plank surfaces. The professor listened to the fire, placing his ear against the back of the burning timber. When he decided they were ready, he wrapped his arms around the burning bundles and lifted them up off their bases, laid them on the ground and then opened them up to extinguish the flames.

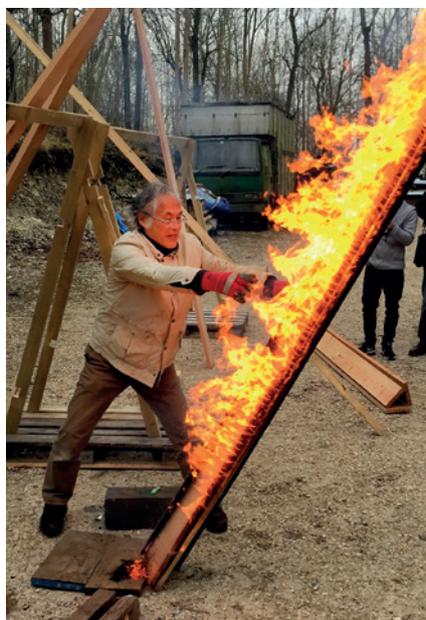
A bundle of burning planks is tipped over to be extinguished. Another triangular bundle can be seen in the background ready for charring.

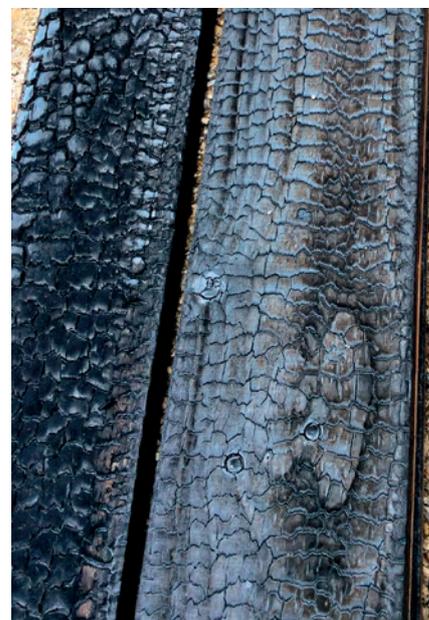
The Douglas fir planks after charring

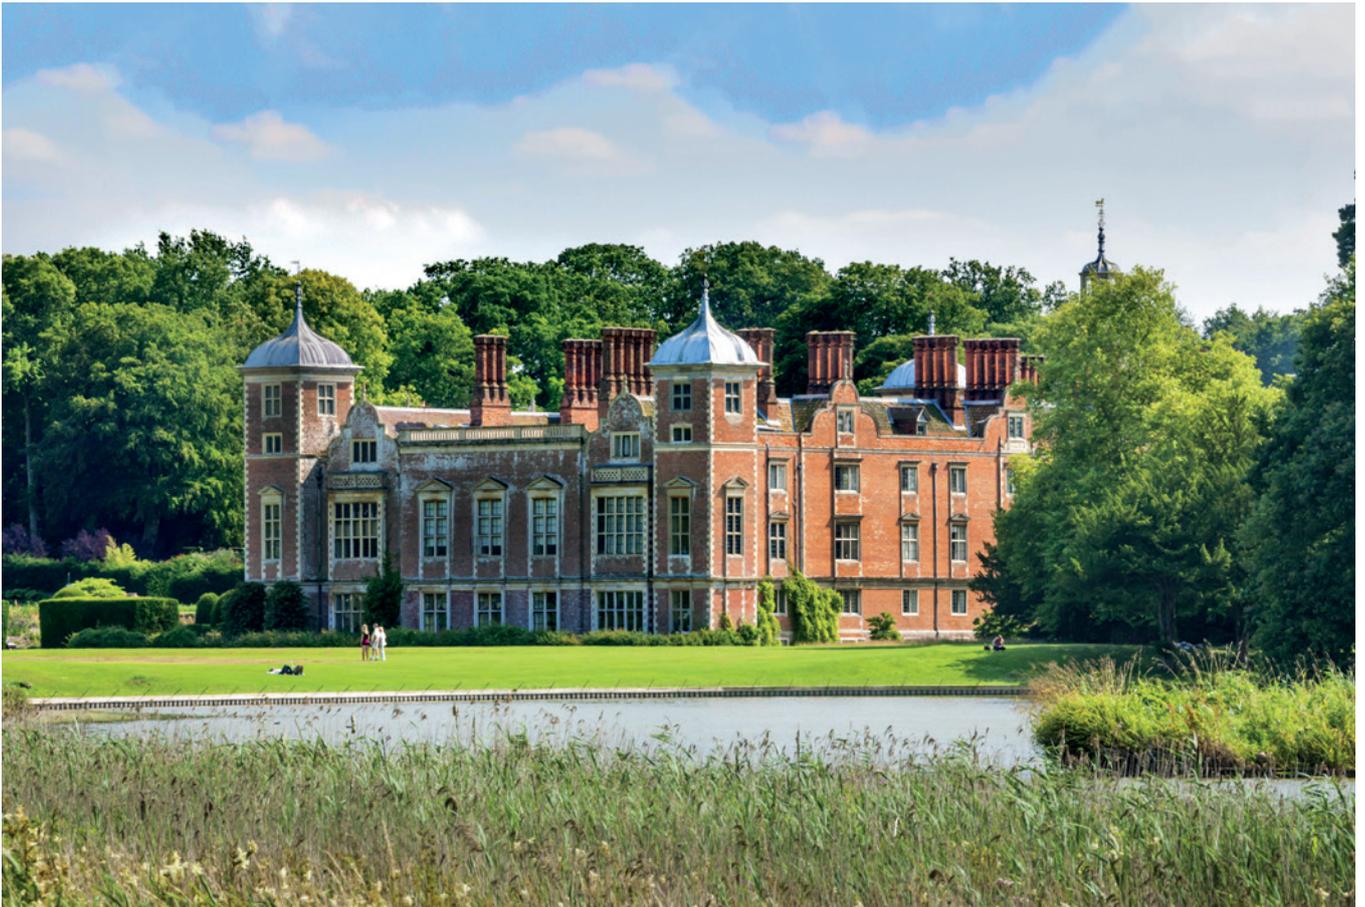
Blickling Hall in Norfolk, where the National Trust recently installed a 200kW lake source heat pump to heat the main hall

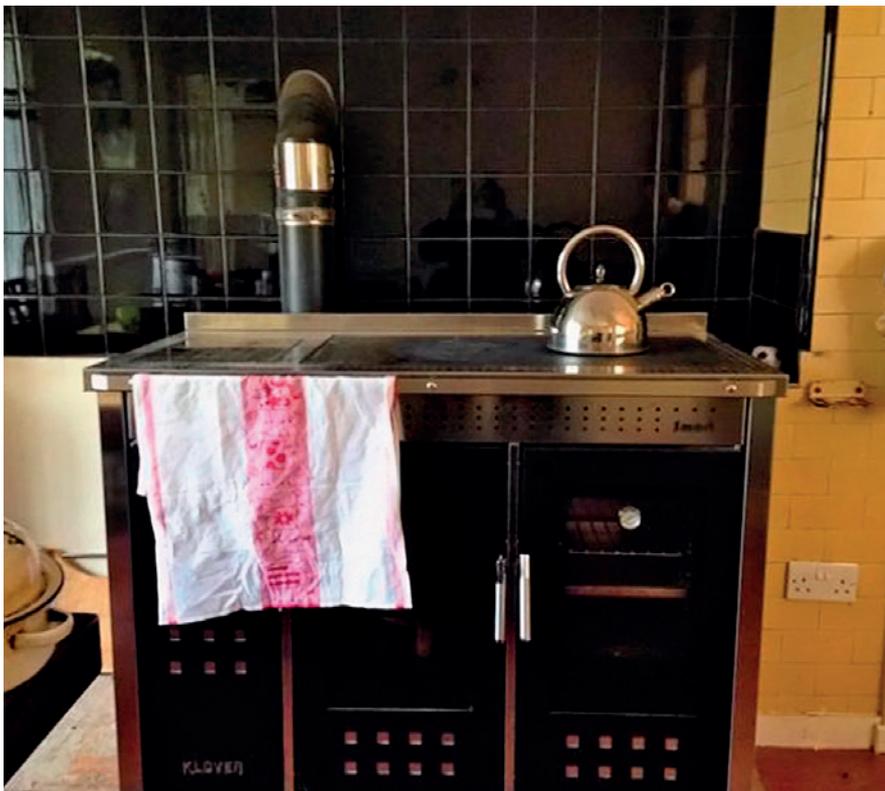
Used to heat the property and for cooking, the wood pellet range cooker trialled at Hafod y Llan in Snowdonia reduced fuel costs considerably and demonstrated that wood pellet ranges are a viable alternative to the oil-fired models used in many similar properties.

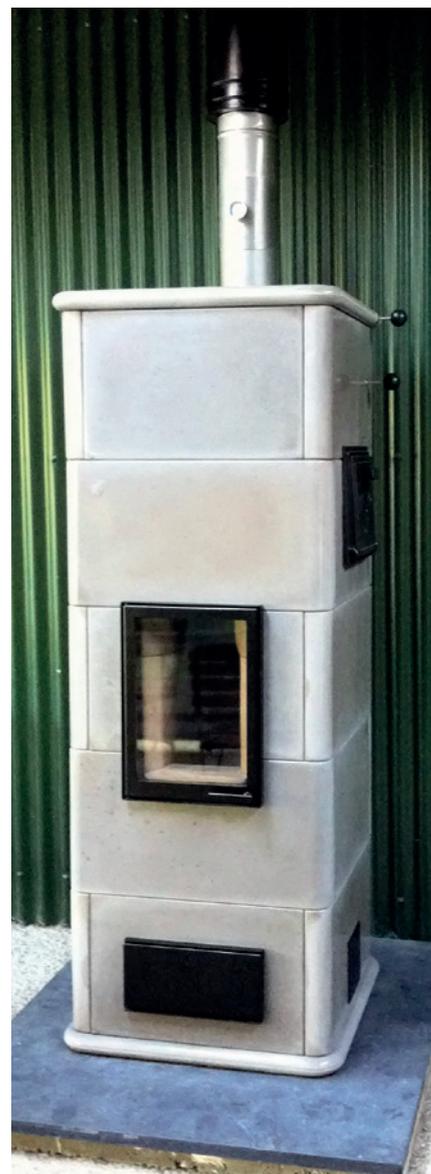
Wood-fired storage heater or 'masonry stove' at Llanerchaeron, Ceredigion

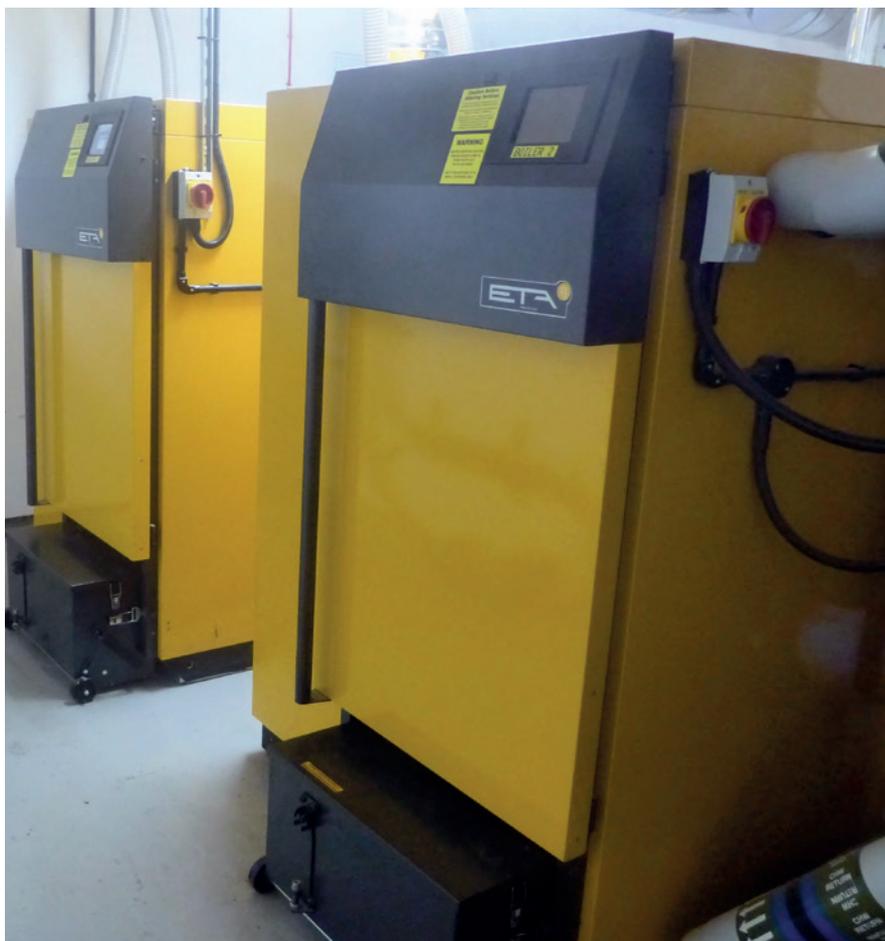
Upton House, Warwickshire was using 25,000 litres of oil each year before the installation of two wood pellet boilers, which are now saving £6,000 a year on energy bills and 55 tonnes of CO₂ emissions.
